Project Name	National Route 42 restoration work (emergency measurement)
Purpose of Project	Restoration from the road cave-in due to Typhoon No.19
Location	Hime, Kushimoto-cho, Higashi Muro-county, Wakayama, JAPAN
Project Owner	MILT
Main Contractor	SHIMIZU CORP.
Piling Contractor	GIKEN SEKO CO., LTD.
Duration	March 2020 to June 2020
Press-in Machinery	Silent Piler F401-G1200
Pile Section & Length	Large/Small Pile φ1000/318.5, t=9/10.3mm, L=19.3(1 joint)/10.9m
Features & Remarks	<ul style="list-style-type: none"> <li>- Steel tubular piles were used for the retaining wall because the wall can be constructed in a short period of time and also prevent the repeated damage.</li> <li>- Although there were cobbles in the surface and bedrock in a lower layer, the work was able to be carried out by using rotary press-in method which enables tubular piles with cutting bits to be installed.</li> <li>- Small diameter piles were installed between steel tubular piles to prevent washing-out. The small piles were also with cutting bit so that they can be installed even into the hard ground.</li> </ul>

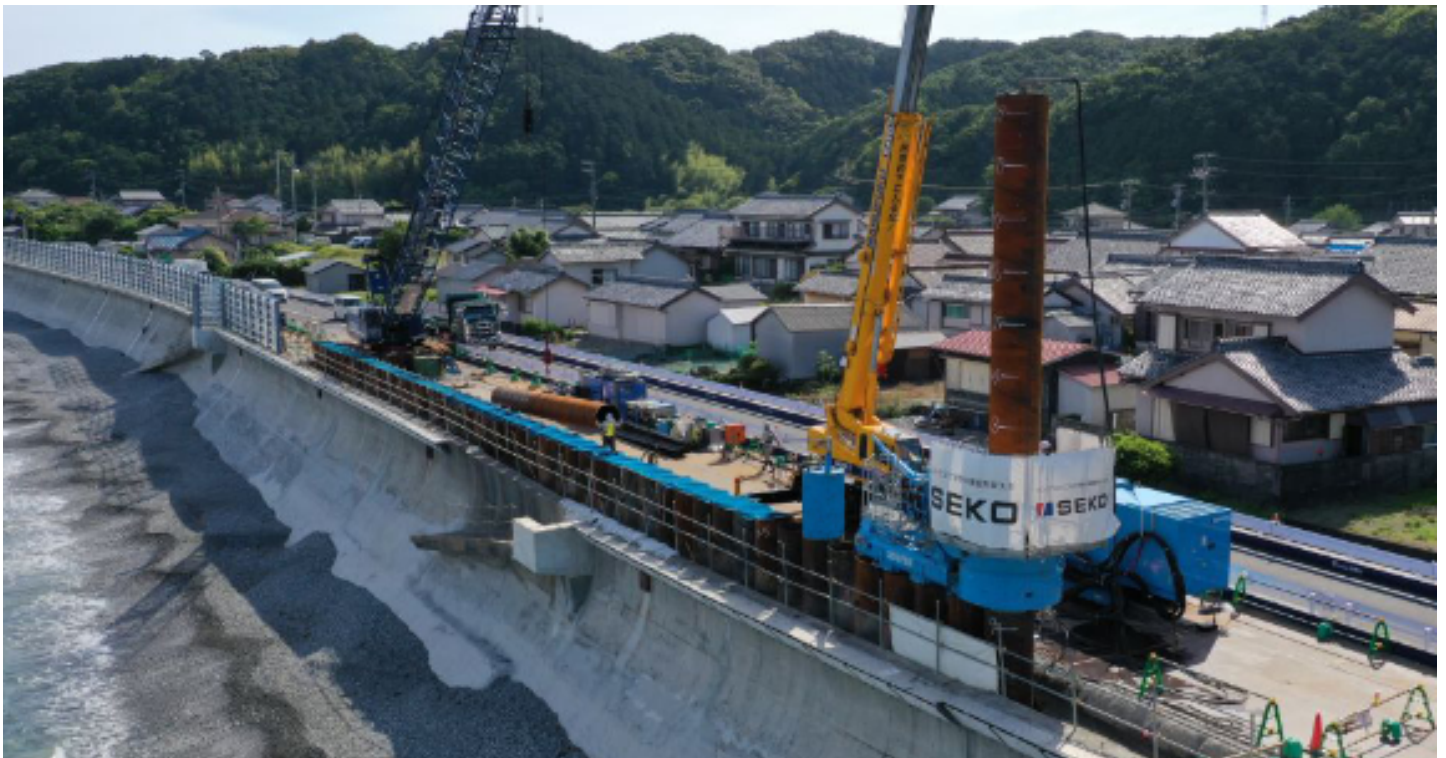
Construction in progress

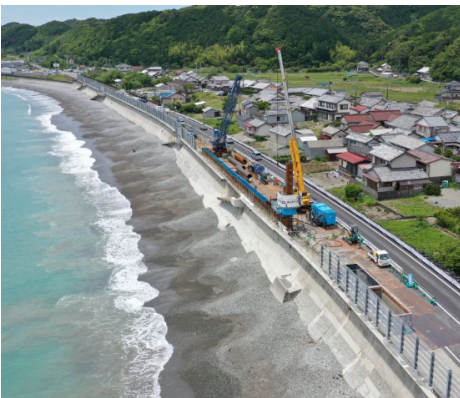
Full view

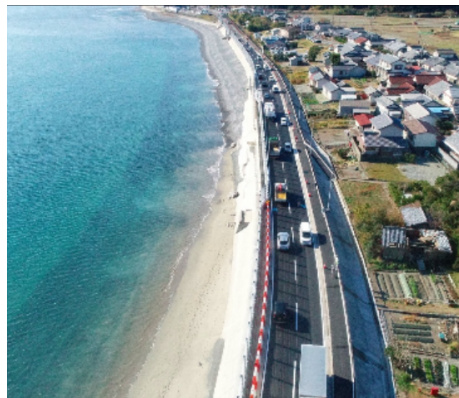
After construction
